Whirl Wind Propellers

SERVICE LETTER

SL-GA-J2B-012714

TO: ALL OWNERS / OPERATORS OF AFFECTED PROPELLERS
SUBJECT: BLADE CLAMP BOLT CRACK
DATE: JANUARY 27, 2014

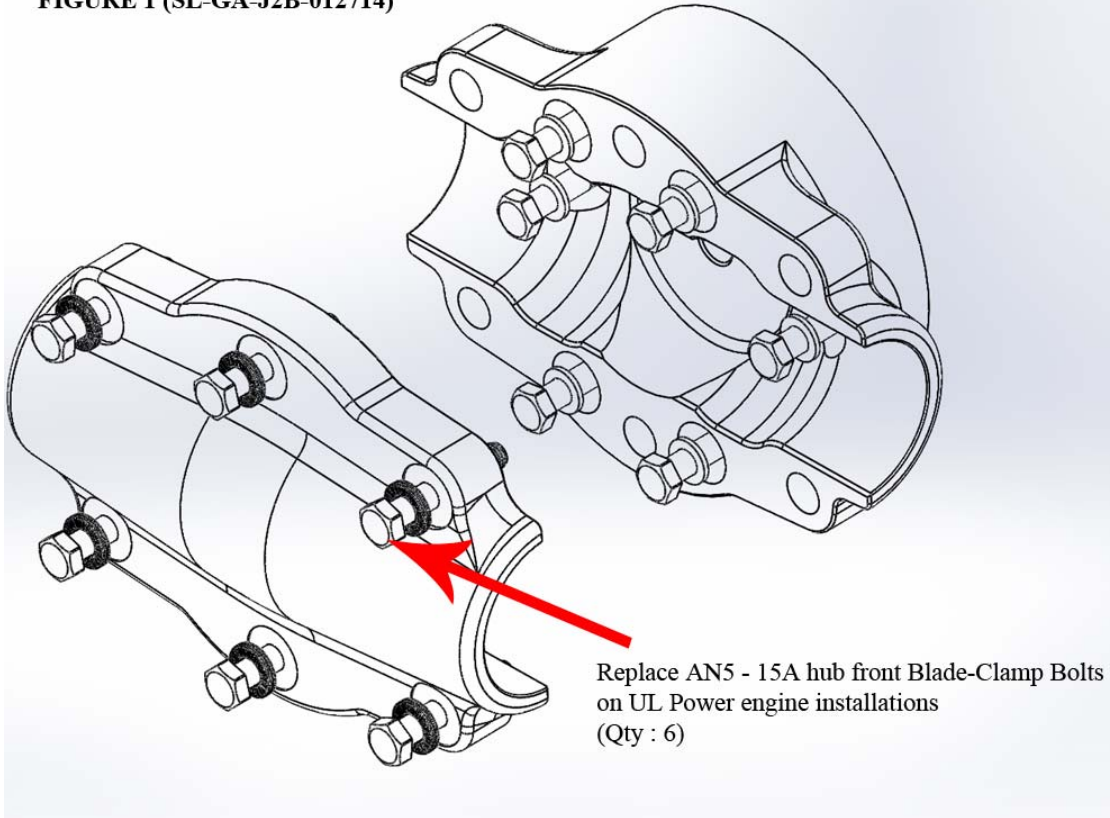
FIGURE 1 (SL-GA-J2B-012714)

REASON: Upon routine inspection of a **GA-J2B** propeller in the affected Serial Number range, installed on a UL350is engine, one of the propeller hub blade-clamp bolts (AN5-15A) was found to have a crack. The propeller was installed on a UL-350is engine, with 65" diameter blades. The propeller had 300+ hours total time. The bolt crack found so far has been an isolated case.

Recommend replacement of all 6 front hub blade-clamp bolts (AN5-15A) at time of every Annual or every 100 hrs, whichever occurs first.

Mandatory replacement of all 6 front hub blade-clamp bolts (AN5-15A) before next flight.

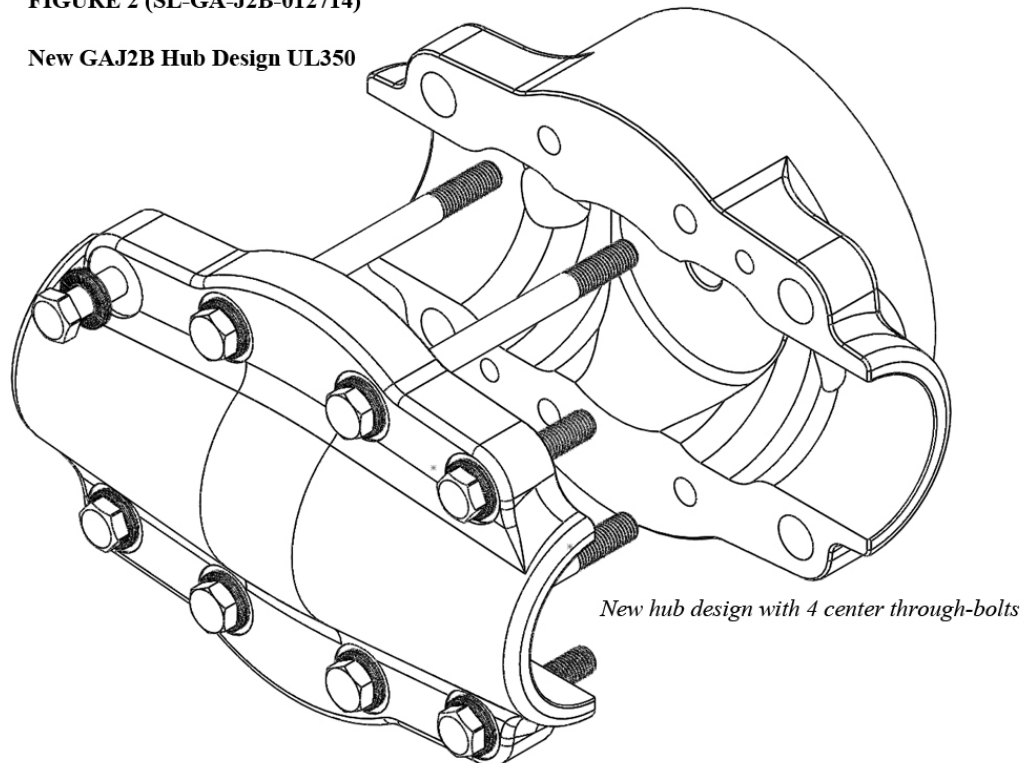
FIGURE 2 (SL-GA-J2B-012714)

New GAJ2B Hub Design UL350

Optional: Owners of affected propellers may trade-in affected propeller hub and purchase new style UL350 hub (See Figure 2) at reduced cost. Contact WhirlWind Propellers directly for pricing.
