October 15, 2001

**Dear STOL builder:**

STOL  
701/801

TOP CHANNEL ZEE REINFORCEMENT

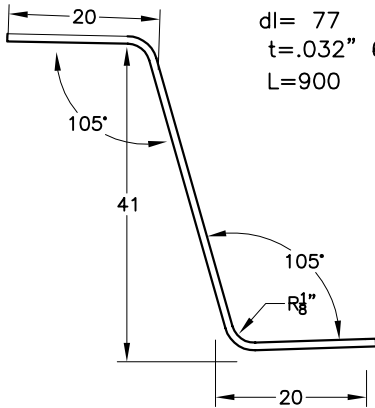
PART NUMBER: 7F5-3Z

For those of you who may be operating the aircraft in excess of the published VNE and/or at weights higher than the published gross weight figures (you know who you are!), I recommend that the Top Channel be reinforced (see following drawing F5-3Z). Two such aircraft have been reported to have shown signs of buckling along the middle portion of the Top Channel.

ADDITIONAL REINFORCEMENT Z ANGLE  
WHEN 7F5-3 OR 7F5-3SP IS t=.040"  
(NOT REQUIRED IF 7F5-3SP IS  
t=.063")

dI= 77  
t=.032" 6061-T6  
L=900

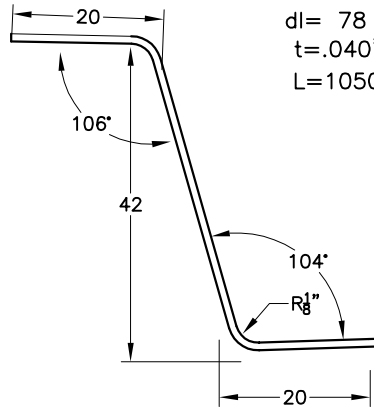
PART NUMBER: 8F5-3Z

ADDITIONAL REINFORCEMENT Z ANGLE  
WHEN 8F5-3 IS t=.040"  
(NOT REQUIRED IF 8F5-3 IS t=.063")

dI= 78  
t=.040" 6061-T6  
L=1050
