SAFETY ALERT

September 26, 2013

We have received reports of several rudder pedal deformations and failures recently from an overseas operator. Upon inspection of the failed rudder pedals it was discovered that some of the 4130 chrome-moly tubes used in the welded rudder pedals assembly was thinner than prescribed in the aircraft drawings (0.035-inch wall thickness instead of 0.058-inch wall thickness).

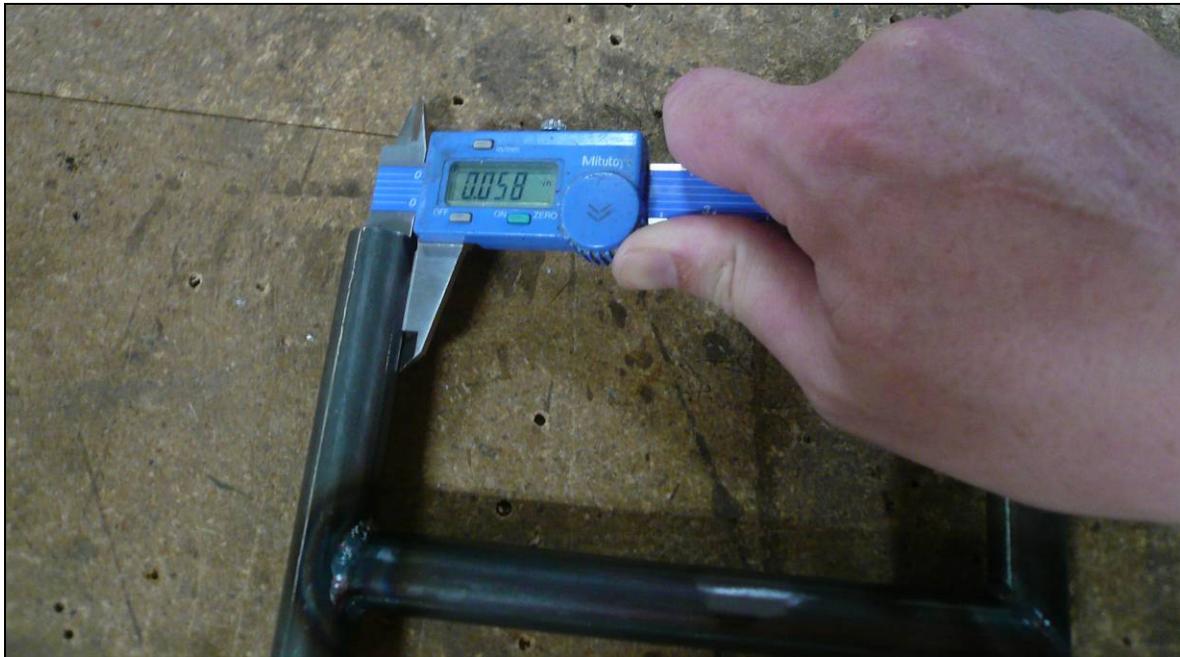
The upper and lower horizontal tubes can be easily checked with a pair of calipers at the open end of the tubes. Before checking, clean the end of the tubes of paint and burs so that an accurate measurement can be taken.

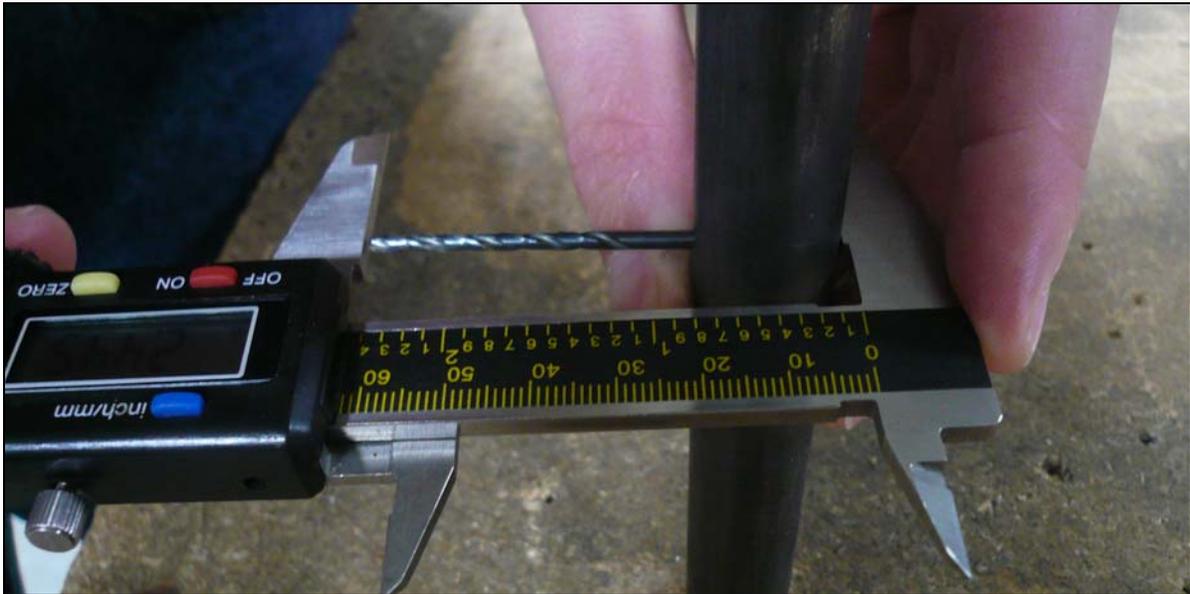
To check the vertical tubes, a small #40 hole must be drilled in the **INBOARD SIDE** or **OUTBOARD SIDE** (so that the drill bit is parallel to the lower horizontal tube) of the tube.

Use a clean #40 drill bit. Insert the drill bit into the hole until it makes contact with the opposite wall of the tube. Hold the drill bit perpendicular to the tube and measure length of the drill bit from the opposite side of the tube.

Subtract the length of the drill bit from the length of the tube and drill bit. This will tell you the wall thickness of the tube. (It is not necessary to fill the hole after drilling it.)
